# Technical Services Laboratory Alpha-Fry Technologies

## **-Case Study-**

### **Post Reflow Open/Intermittent BGA Solder Connections**

#### **('Head in Pillow' Effect)**

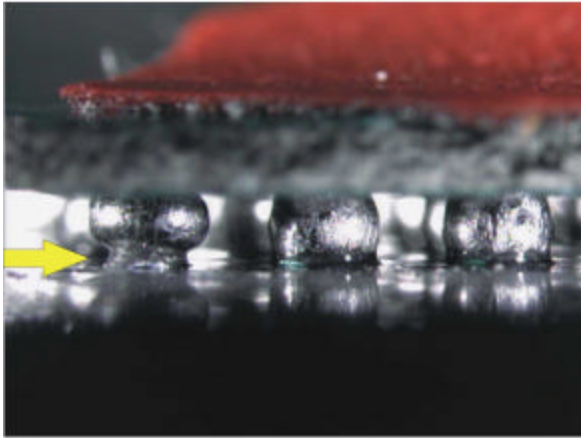
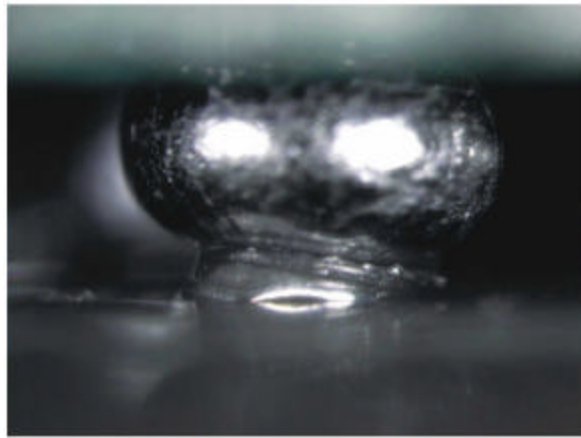
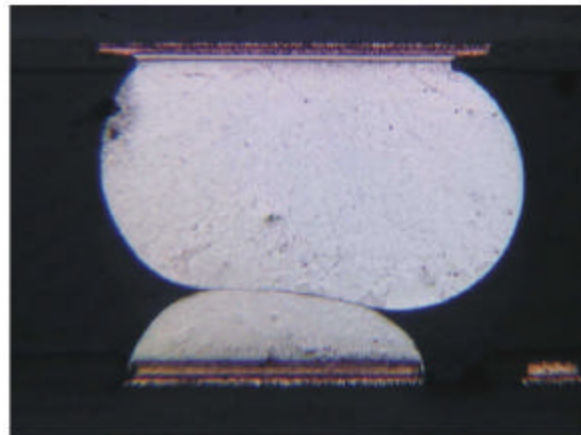
5. Other sites revealed much more doubtful solder connections, appearing as though the solder spheres were just resting on the reflowed solder paste on the attachment pads (See first four photographs attached hereto).

6. At the sites described in item 5, it appeared that the solder spheres were somewhat deformed, some appearing to have even been deflected slightly to one side.

1. As illustrated in the bottom left photomicrograph on the first page of attachments, the separation in the open solder connection is confirmed and is quite clear. This was observed in several connections on all three (3) BGA's submitted. The appearance of these opens strongly suggests that the connections have become molten again after initial package attachment to the motherboard, probably during the second soldering operation.

2. The deformation and deflection of the solder spheres is also confirmed and very apparent in this same photomicrograph and strongly supports the proposal put forth in item 1.

OPEN CORNER CONNECTION

1. Minimize preheat on the BGA side during the second soldering operation. This will reduce warpage somewhat and minimize the chances of reflowing the BGA connections during the second soldering operation.
2. Reduce the soldering parameters (temperature and time) on second soldering operation. This will also have the same effect as previously put forth in recommendation 1.
3. Optimize solder deposition consistency. Minimizing incomplete or light deposits will obviously decrease the probability of this defect, as well as the generation of others.
4. Increase solder paste deposition volumes within reasonable limits in order to better compensate for substrate warpage and solder sphere variations.

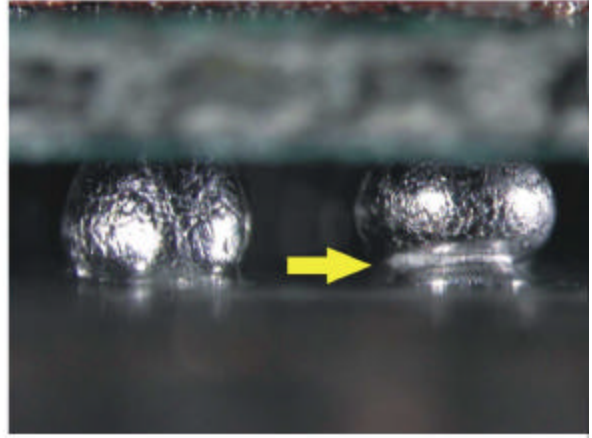
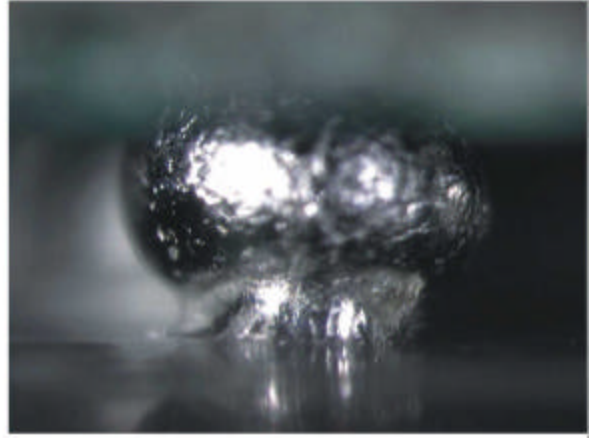
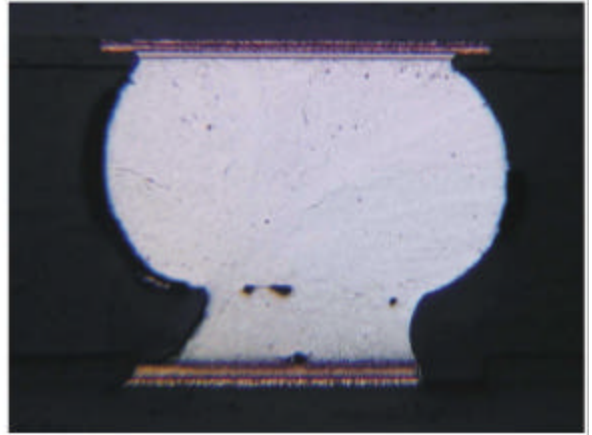
4. Some of the connections appeared to be somewhat stretched or elongated, but still possessed an obvious bond that was continuous between the solder sphere and the reflowed solder paste on the motherboard attachment site (See first four photographs attached).

3. The bottom right photomicrograph on the first page of attachments clearly confirms the stretched and elongated appearance suggested by the initial observations. Note the appearance of the small voids along an apparent "ghost" boundary.

ELONGATED CONNECTION

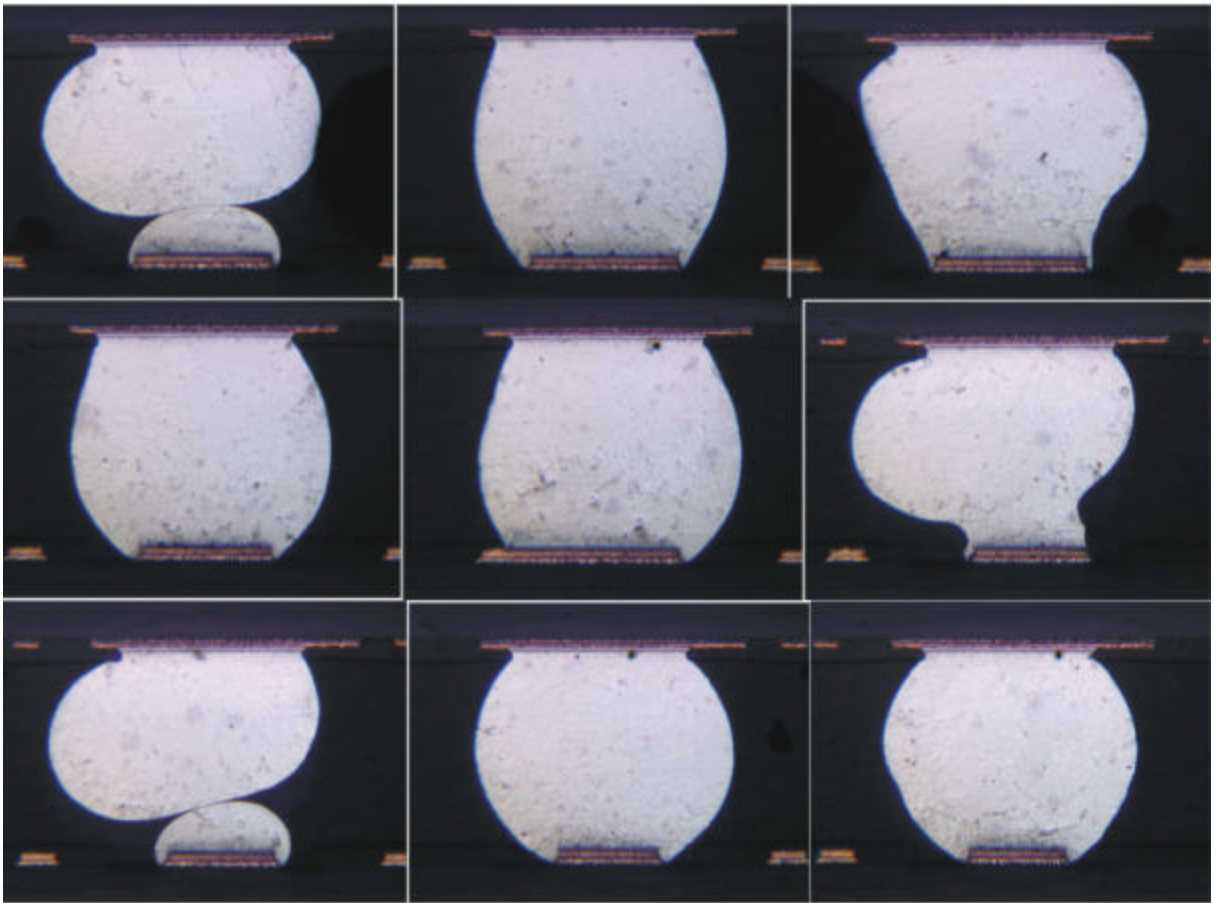
**BGA ASSEMBLY #1**

4. The photomicrographs on the second page of attachments illustrate several connections from each of the three (3) submitted BGA's. Notice the variety of appearances they reveal.

5. The separations in the open solder connections, along with the variations in the connection heights, are also evident in these photomicrographs.
6. The interfaces of the apparent separations, when examined at very high magnifications did in fact confirm distinct separations with slight surface irregularities. This can be seen in the photomicrographs on the third page of attachments.

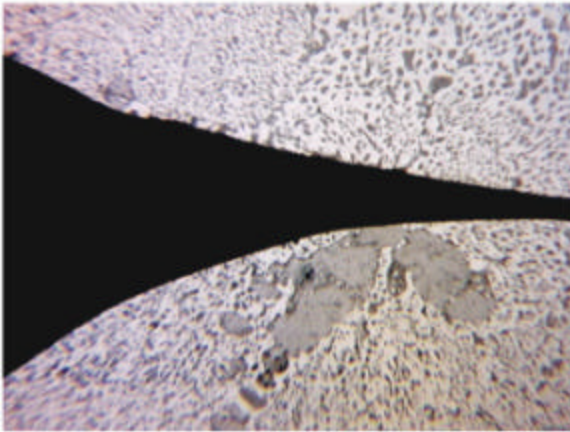
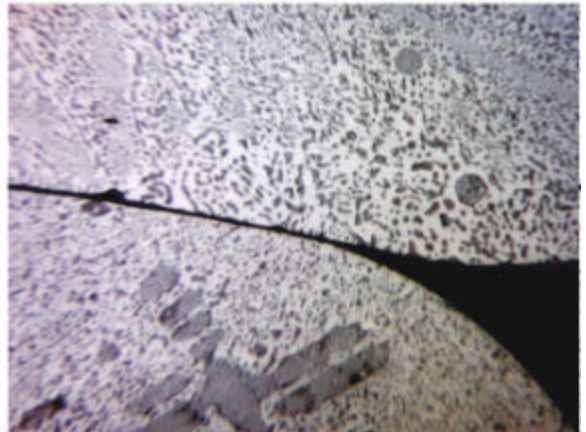
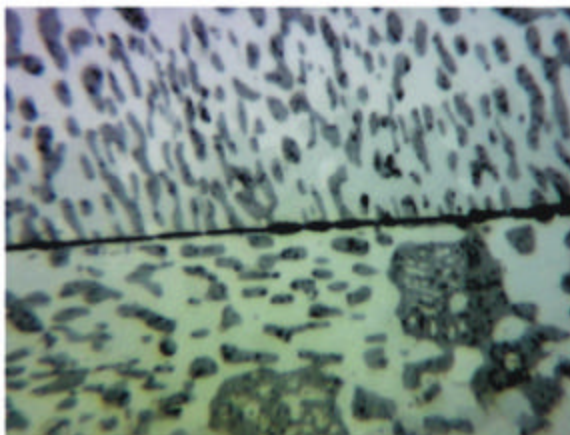
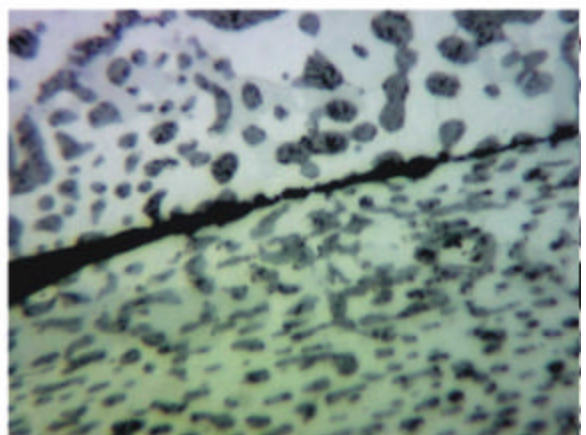
HIGH MAGNIFICATION OF OPEN CONNECTIONS SHOWING DISTINCT SEPARATION

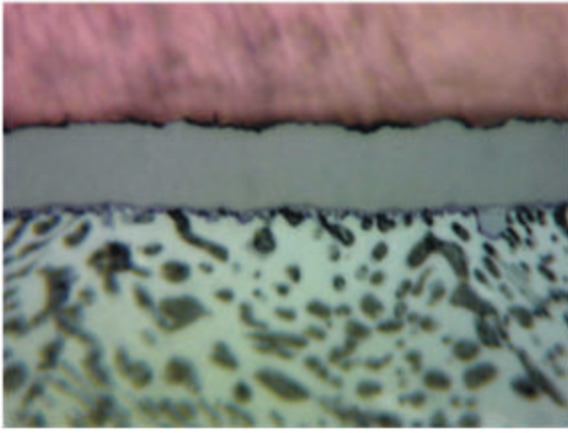
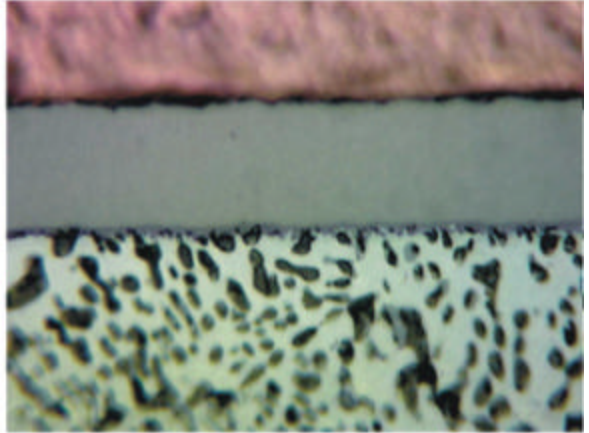
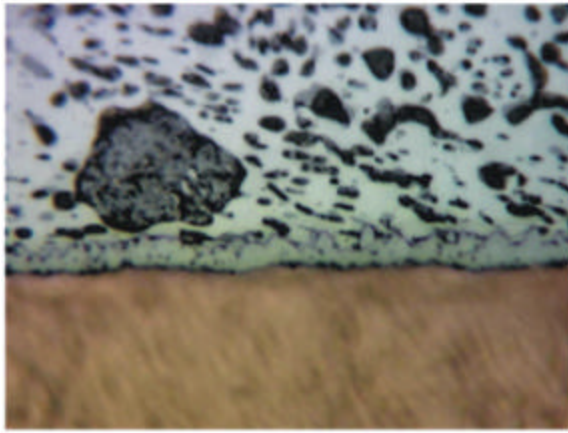
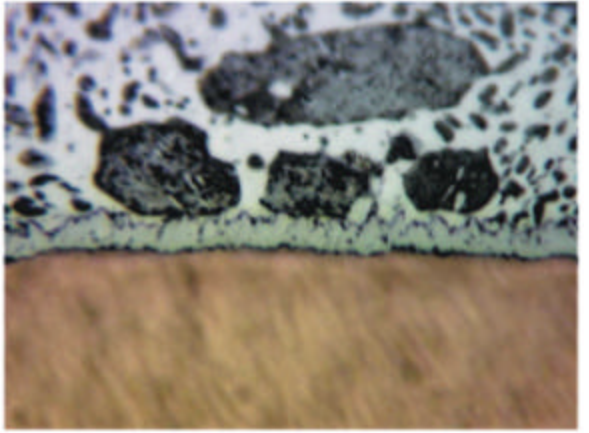
8. The IMC reaction layer formed between the solder and the Ni layer at the BGA component interface was measured to be approximately 20 micro-inches on the average. This is a significant thickness for an IMC reaction layer between Ni and solder. The photomicrographs on the fourth page of attachments, illustrate the typical appearance of the IMC reaction layer observed between the solder and the Ni layer.

9. The IMC reaction layer observed at the solder interface with the Cu attachment pad on the motherboard was measured to have an average thickness of approximately 70 micro-inches. This is quite extensive, even for a substrate that has experienced two reflow operations, and strongly

suggests quite an extensive thermal exposure. Typically each reflow results in an IMC layer thickness of approximately 20 micro-inches between the solder and a Cu surface. The photomicrographs on the fourth page of attachments illustrate the very thick IMC reaction layer formed between the solder and the Cu surface on the motherboard attachment sites.
